TECHNICAL REPORT CERC-88-4

EFFECTIVENESS OF EXPEDIENT LEVEE-RAISING STRUCTURES

Experimental Model Investigation

Coastal Engineering Research Center

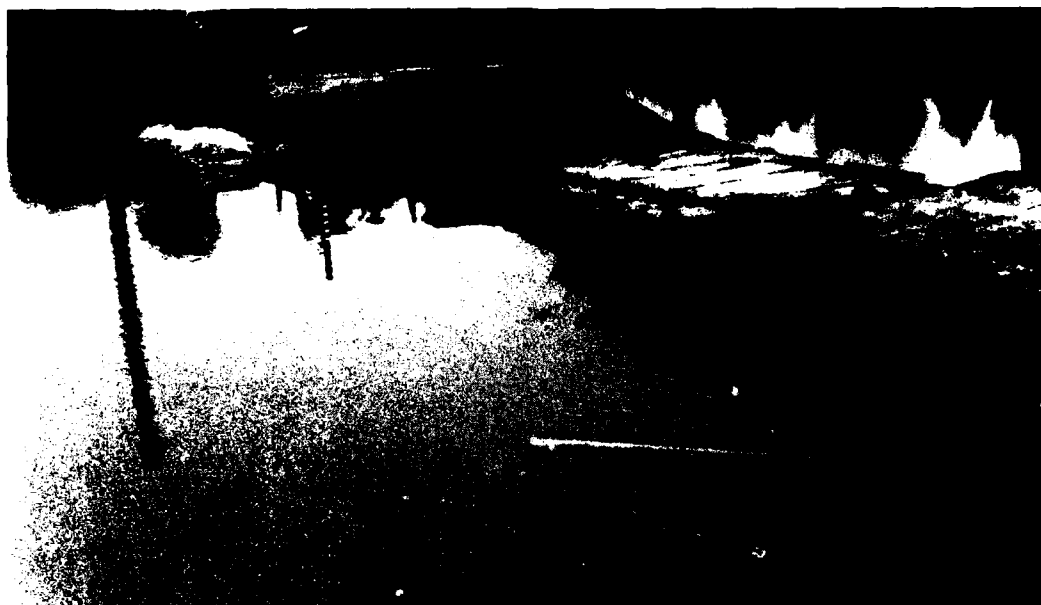
Photo 15. Riverside view of Section 2-1 after testing 8.0 hr of wave action

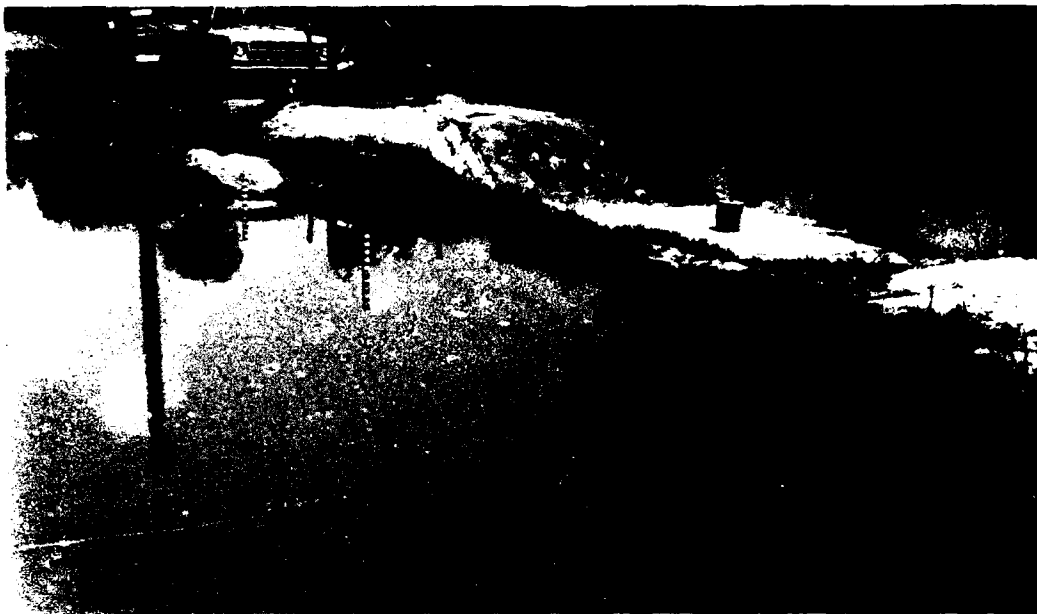
and at the end of wave action tests. Tests were stopped after 19 hr of wave attack. While the structure had not breached, erosion was continuing at a very slow rate and would have eventually caused total failure if wave action had not been stopped. Photo 20 and two cross-sectional soundings (Plate 3) show the degree of erosion sustained by the compacted clayey-silt potato ridge.

Photo 17. Riverside view of Section 2-1 after testing 19 hr of wave action (end of test)

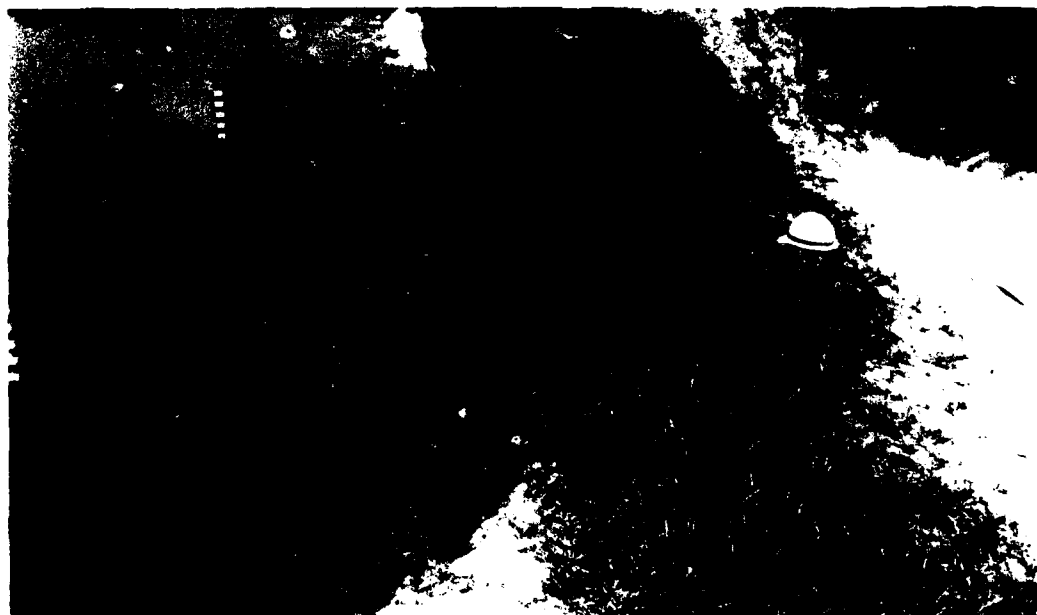
Photo 18. End view of Section 2-1 after testing 19 hr of wave action (end of test)

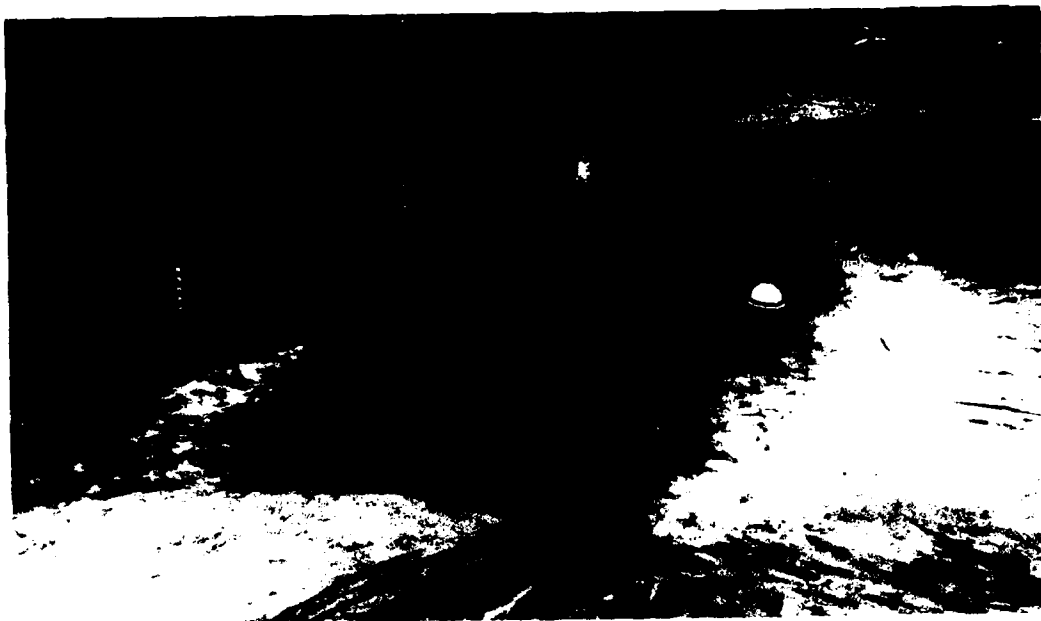
Photo 19. Landside view of Section 2-1 after testing 19 hr of wave action (end of test)

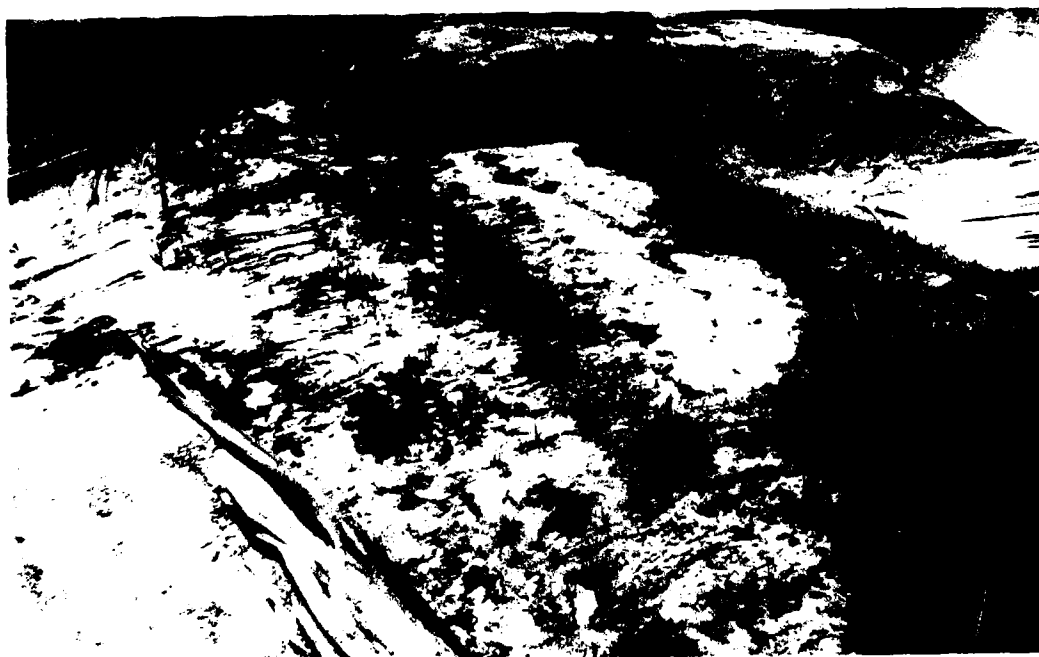
degree than in the lap joint area. After 2 hr of wave action, three sandbags were placed at the center of the riverside slope in an attempt to slow the erosion rate occurring at the lap joint (Photo 24). The sandbags helped for a short period, but these bags and all other sandbags exposed to wave action were emptied quite readily. It was obvious that the sand fill was too fine for the porous burlap bags when exposed to wave action. Unlike Section 2-1, whose crown and upper slopes remained firm and dry to the touch, Section 2-2 appeared to have a very spongy texture after the first few days of testing. The poly covering contained moisture, and large beads of condensed water were noticeable on the inside of the poly. Thus, even though the poly was reducing wave energy impinging directly on the structure, it was at the same time keeping the soil saturated (surface moisture could not evaporate as it would have on an unprotected structure, Section 2-1) which in turn made the soil more susceptible to erosion. Therefore, after 19 hr of wave action, it appeared that the erosion of Section 2-2 had progressed to approximately the same degree as had occurred on Section 2-1 after the same duration of wave attack. Photo 25 shows the test section after 10 hr of wave action and Photos 26 and 27 show the condition of the structure after 19 hr of wave action. The poly covering was removed (Photos 28 and 29) to take cross-sectional sounding (Plate 5) to compare to test results of Section 2-1. Comparison of Photos 20 and 28 and Plates 3 and 5 shows that both sections sustained comparable damage.

Photo 20. Riverside view of Section 2-1 at end of test (small basin drained)

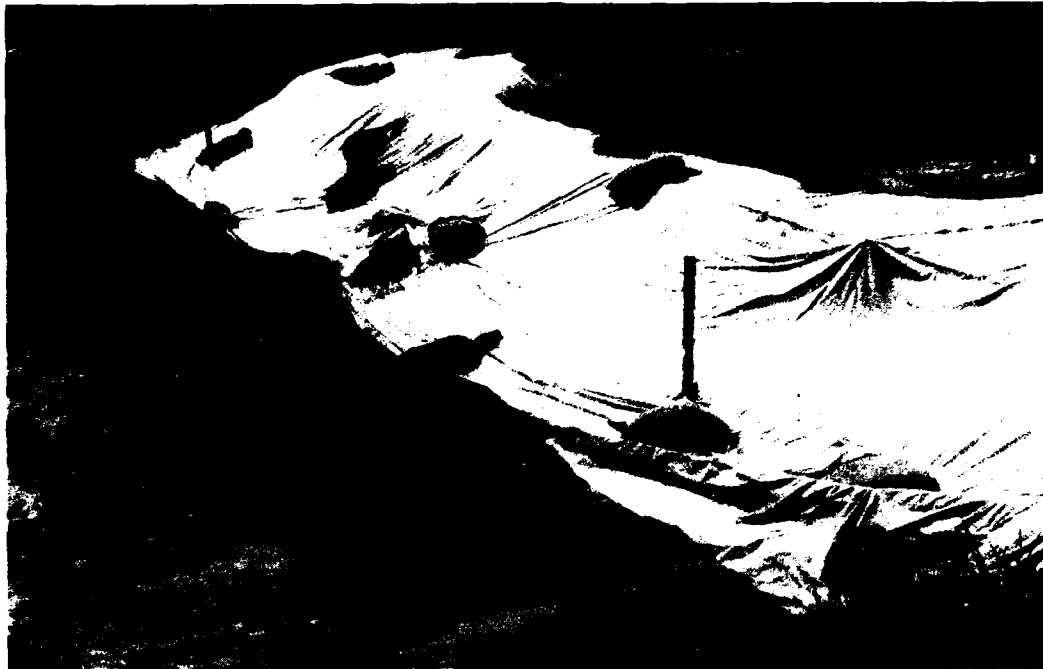
15. Section 2-2. Section 2-2 (Plate 4 and Photos 21 and 22) consisted of a 2-ft-high potato ridge constructed of the same material and compacted (average moisture content = 17.5 percent dry weight; average wet density = 107.0 pcf; average dry density = 91.1 pcf) in the same manner as Section 2-1. The potato ridge was moved 1.5 ft riverward in the cut relative to the position previously occupied by Section 2-1, and the structure was covered with an opaque, 6-mil polyethylene (poly). The poly extended from 4 ft down the riverside slope of the existing levee to 1.5 ft beyond the landside toe of Section 2-2. Two sheets of poly were used along the length of the test section and were overlapped 3 ft at the center of the structure to simulate prototype conditions where two poly sheets were joined. Three methods of sandbag placement (as recommended in various district manuals) were used to hold the poly in place. These consisted of (a) laying the bags on the poly, (b) tying them to the poly, and (c) tying them at the opposite ends of a rope that extended over the potato ridge. Method (c) is recommended when placing the poly in standing water, while the other two methods, especially tying the bags to the poly, would have to be done before the water reached the area being protected.

Photo 21. Riverside view of Section 2-2 before testing

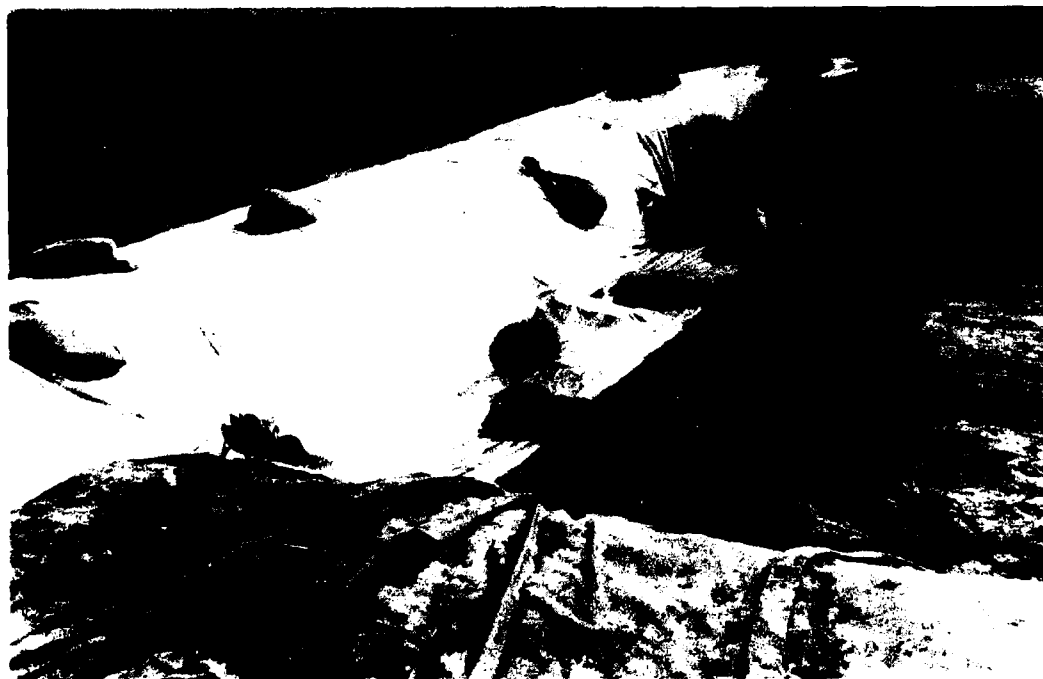
Photo 22. Landside view of Section 2-2 before testing

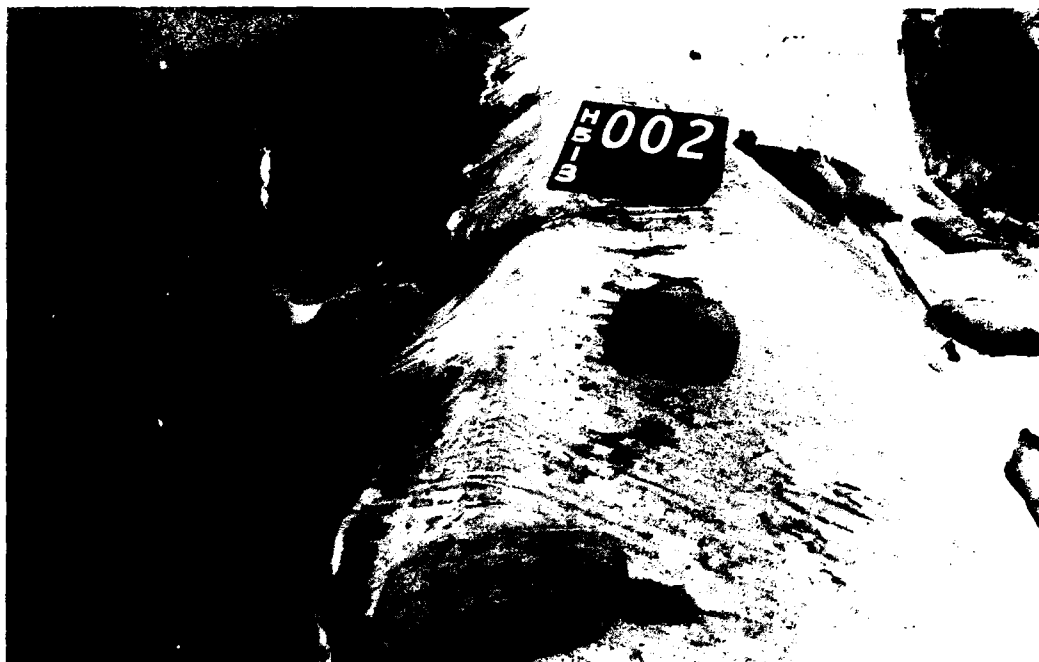
16. The compacted clayey silt potato ridge had already proven to be stable for static differential heads up to 1.5 ft (Section 2-1), and the poly covering was added to see if it would provide adequate protection to prevent erosion resulting from wave wash. For this reason, Section 2-2 was not tested for static differential head conditions. The water depth in the small basin was raised to 1 ft relative to the toe of Section 2-2 and let stand for 24 hr to allow the clayey silt embankment to reach a static saturation level. The test section then was exposed to 34-1/2 hr of wave action over a period of 362 hr. The test section began to erode at the lap joint immediately after the wave action was started (Photo 23). The poly was more loose in this area, apparently allowing more wave energy to reach the embankment. Other portions of the riverside slope were eroding beneath the poly but to a much lesser

Photo 23. Side view of Section 2-2 after 0.5 hr of wave action at the 1.0-ft water level

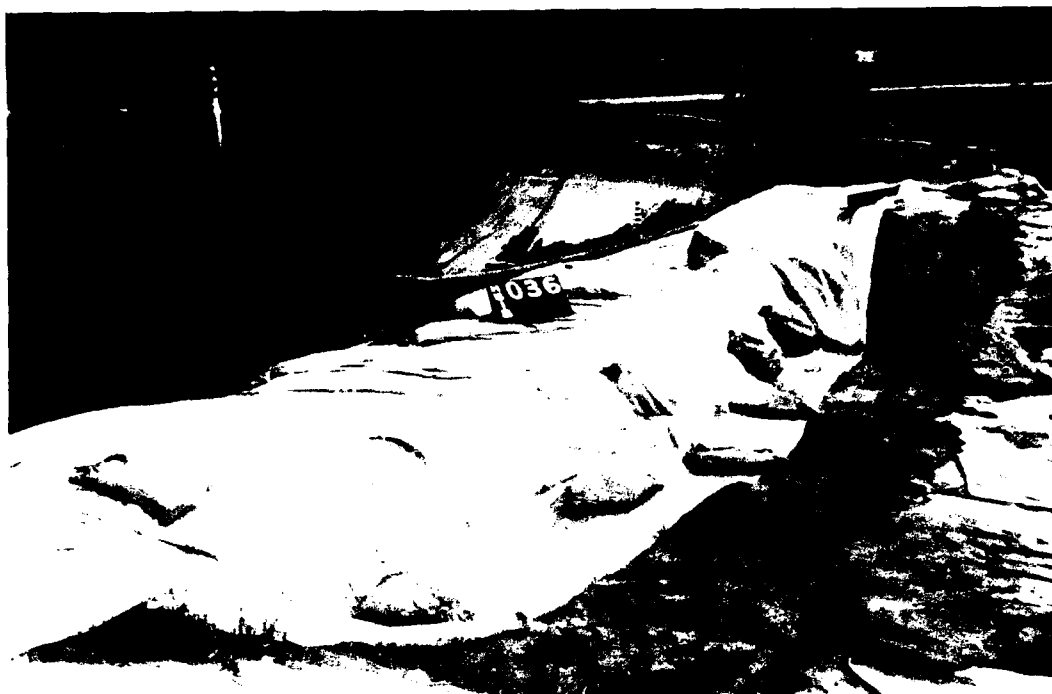
below the breach elevation. Photos 30 and 31 show the condition of the test section after the small basin was drained. The structure was uncovered (Photo 32), and a cross-sectional sounding was made through the breach in the structure (Plate 6).

Photo 31. Landside view of Section 2-2 after 34.5 hr of wave action
at the 1.0-ft water level

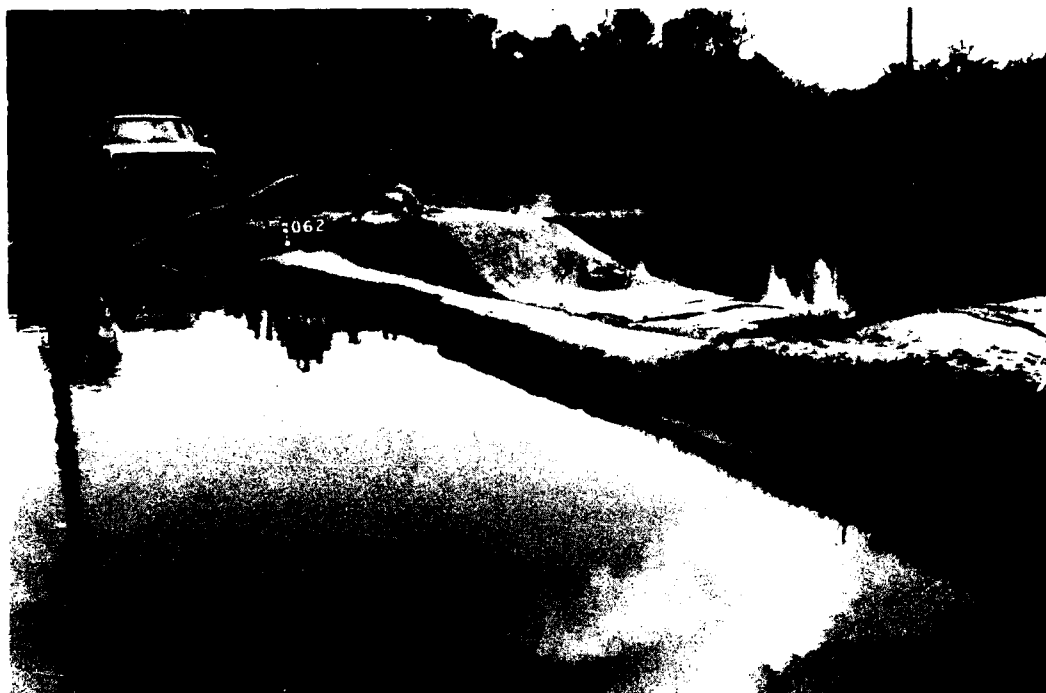
Photo 41. Riverside view of Section 2-3 after 28 hr of wave action
at the 1.0-ft water level

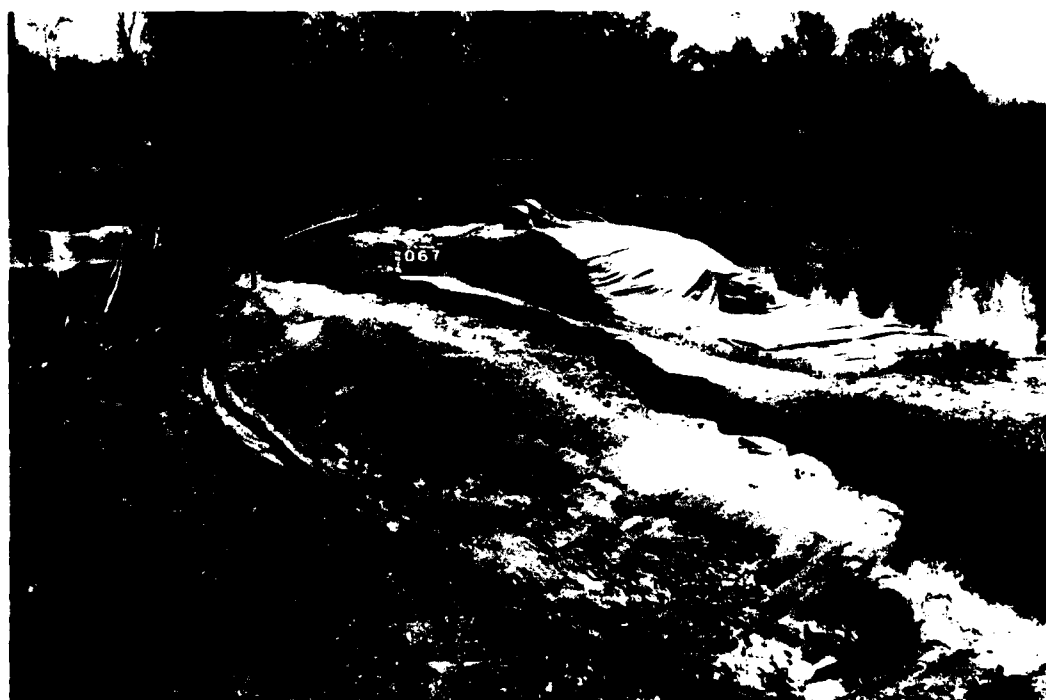
Photo 42. Riverside view of Section 2-3 after 12.5 hr of wave action
at the 1.3-ft water level

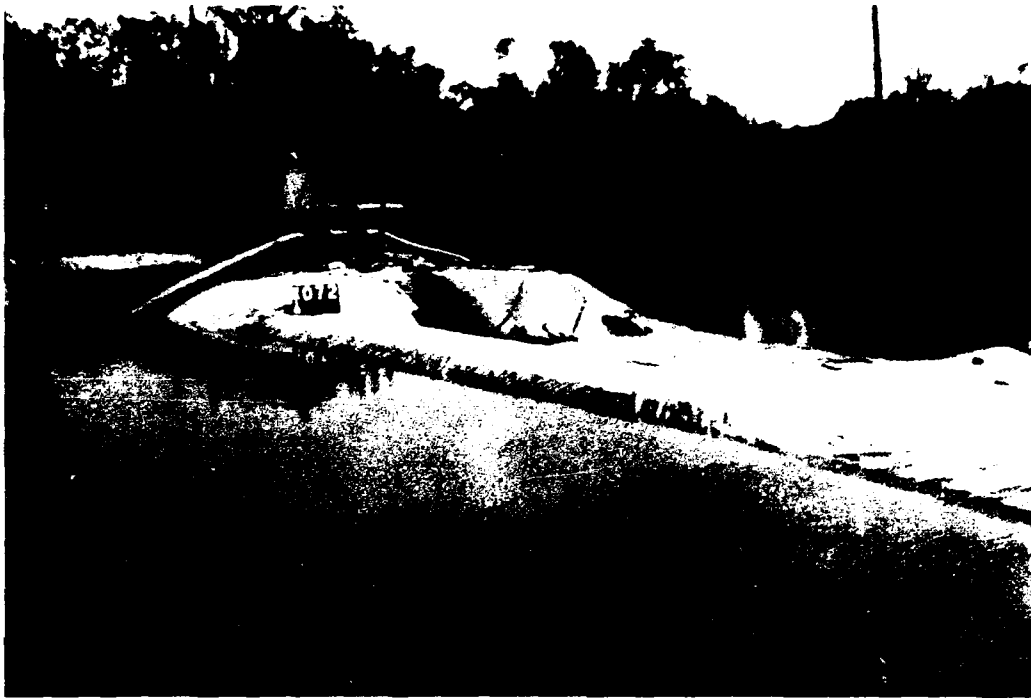
24. Section 2-4 was exposed to 24, 95, and 24.5 hr of 0.5-, 1.0-, and 1.5-ft static differential heads, respectively, and no significant seepage or stability problems were observed (Photos 49 and 50). By the end of the static head tests, the test section was spongy. As in Section 2-2, the poly trapped the moisture that would have otherwise dissipated through evaporation. Without evaporation, the structure became saturated with water that entered

Photo 49. Riverside view of Section 2-4 after testing 0.5-, 1.0-, and 1.5-ft static differential heads

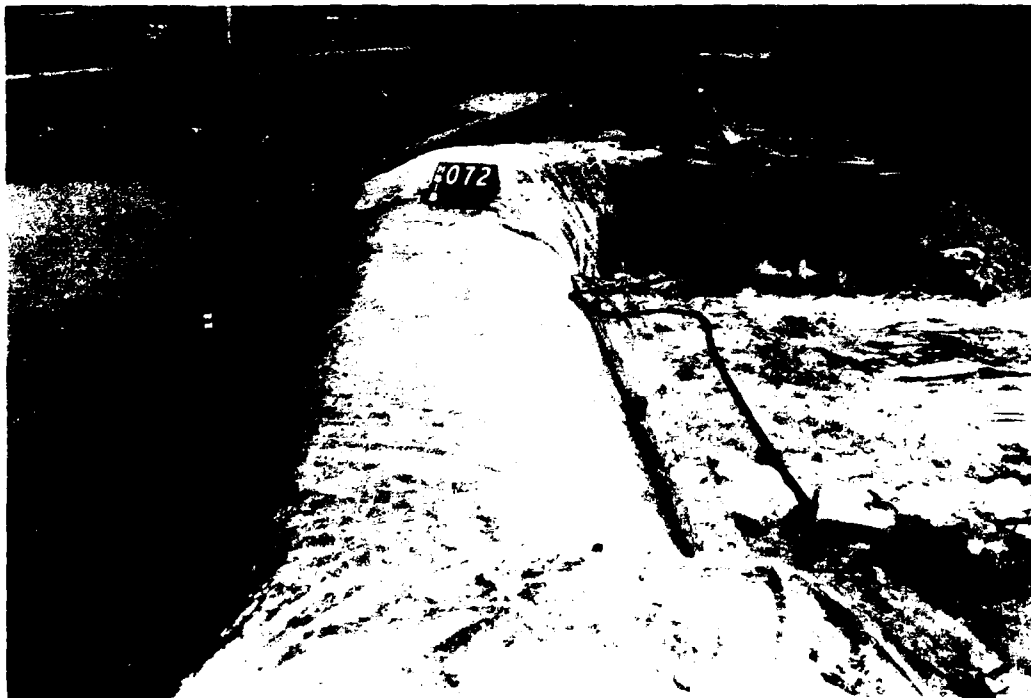
Photo 50. Side view of Section 2-4 after testing 0.5-, 1.0-, and 1.5-ft static differential heads

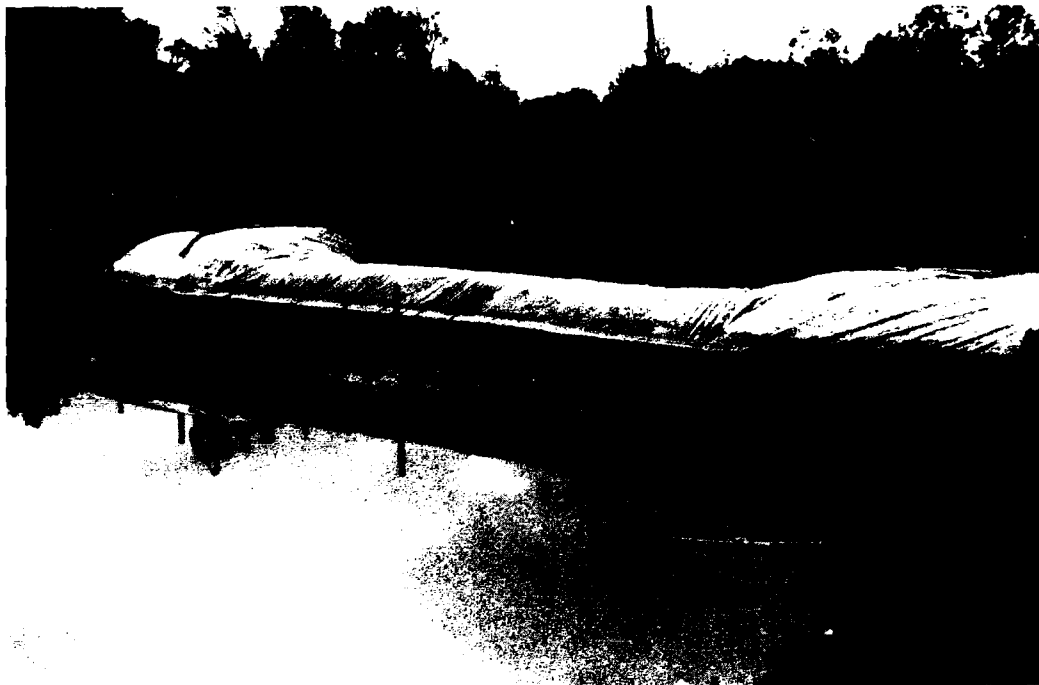
25. Following the static head tests, the water level in the small basin was lowered to 1.0 ft, and the structure was exposed to 19 hr of wave action over a period of 266.5 hr. Erosion of the soil in the wave action zone beneath the poly started immediately. The erosion rate slowed as the test progressed and had all but stopped by the 19th hour of wave action. The small basin was drained to document the condition of the test section (Plate 13 and Photos 51 and 52). The eroded material was contained by the poly but had produced a large bulge on the riverside toe and had stretched the poly very tight. Tension cracks were appearing along the crown of the structure, and the riverside of the crown was being vertically compressed due to forces being applied by the stretched poly covering. The poly had not torn loose on the landside toe, but it was showing signs of stretching and tearing at the points where the anchor pins projected through the poly. It was noted throughout wave action at the 1.0-ft water level that minor amounts of material were being pumped out of the structure through 2 or 3 small holes (diameters equal to approximately 1/4 in.) in the poly on the lower riverside slope. This material loss was insignificant, but it did show that material could be pumped through the holes by wave action; and if the holes were large enough, the material loss could have been significant. It is surmised that large losses of material would have eliminated the bulge that occurred on the riverside toe and would have kept the poly from stretching tight. Thus the protection provided by the bulge and tight poly covering would have been reduced, and the erosion action would have been more rapid and extensive resulting from large amounts of wave energy reaching the uneroded portions of the structure.

Photo 51. Riverside view of Section 2-4 after 19 hr of wave action
at the 1.0-ft water level

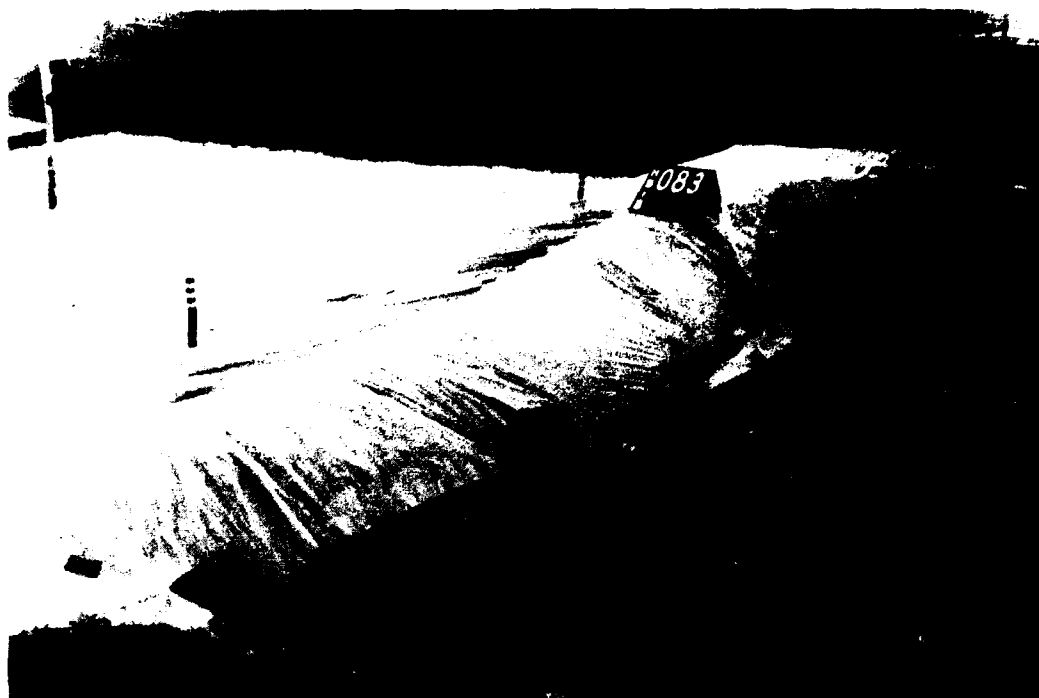
eroded material increased the height of the bulge in the poly toe. This increased height tripped the wave farther riverward and thus dissipated the wave energy that had previously produced the wave overtopping. After 14.5 hr of wave action, the poly had pulled loose halfway across the landside toe (Photo 53). The poly continued to be torn loose and move riverward as the material in the bulge on the riverside toe migrated down the slope of the existing levee. After 18 hr of wave action, the poly had been pulled over the crown on a portion of the structure (Photo 54). From this point on, the erosion rate became more rapid. After 25.5 hr of wave action, the crown was gone on the center one-third of the structure (Photo 55), and water was overtopping the structure during wave action. The structure was left for the weekend with a 1.3-ft water level in the small basin, and at some time during the weekend the structure breeched. The remaining water was pumped from the small basin, and the condition of the structure was documented (Plate 14 and Photos 56 and 57).

Photo 53. Landside view of Section 2-4 after 14.5 hr of wave action
at the 1.3-ft water level

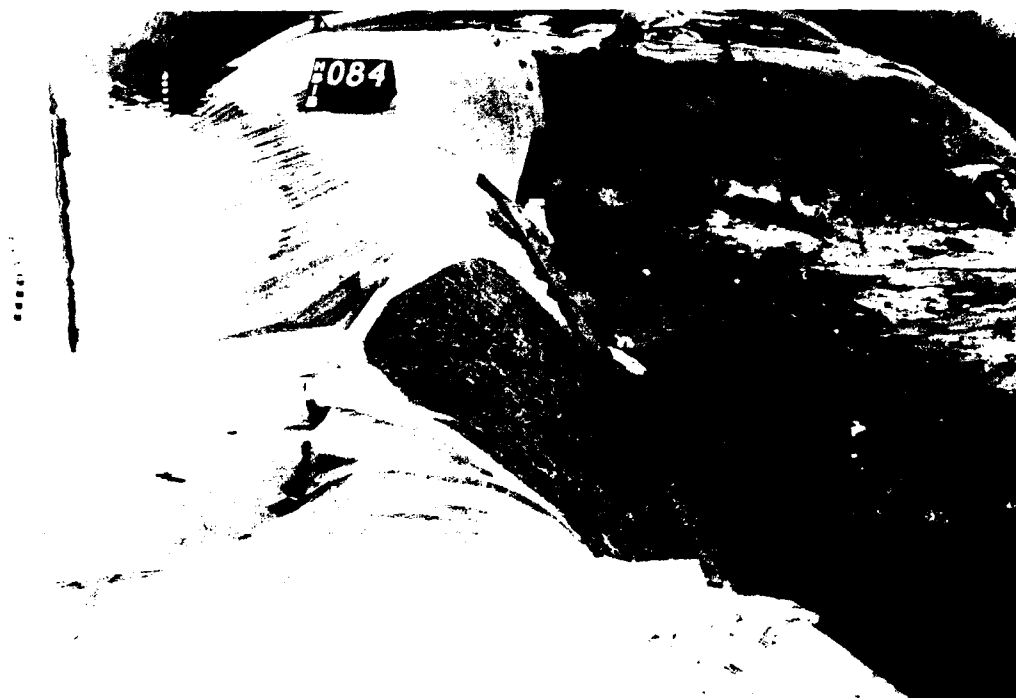
Photo 54. Side view of Section 2-4 after 18 hr of wave action
at the 1.3-ft water level

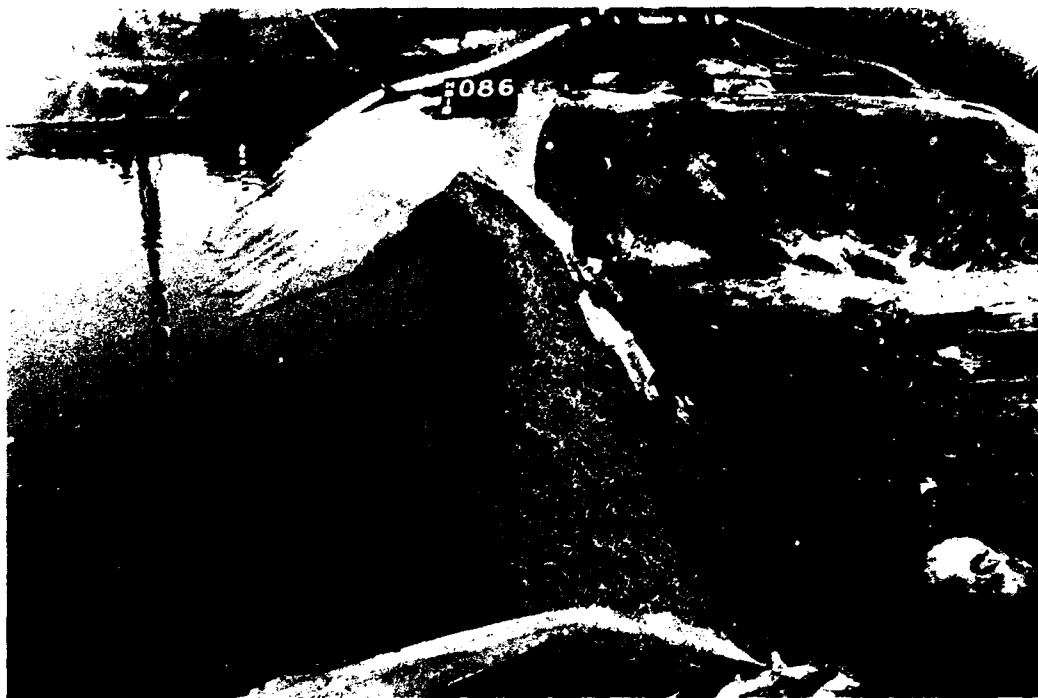
Photo 55. Side view of Section 2-4 after 25.5 hr of wave action
at the 1.3-ft water level

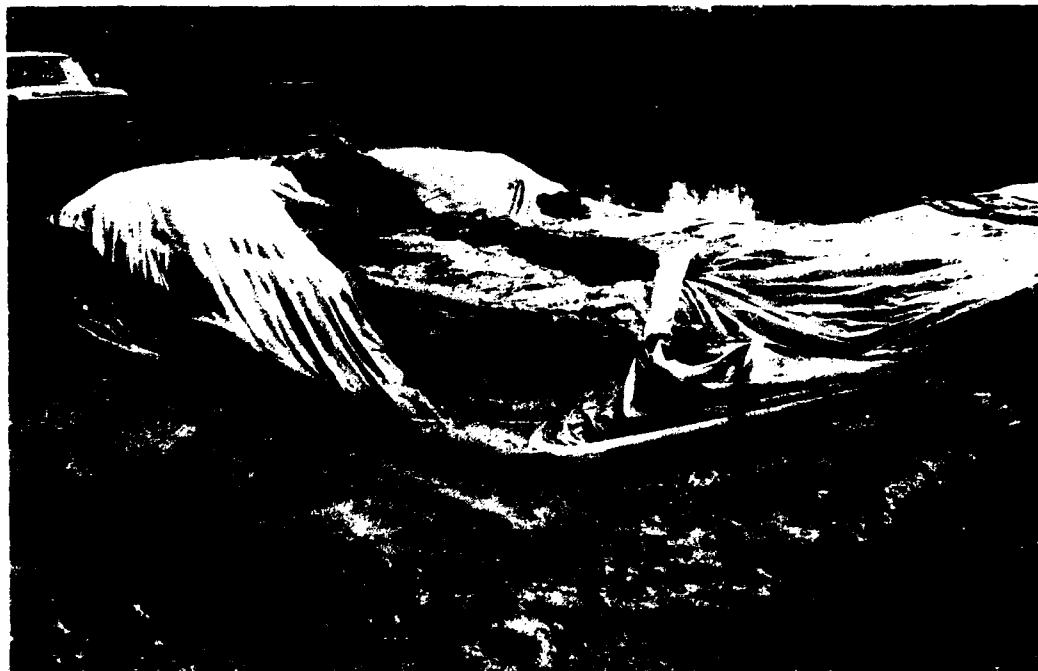
Photo 56. Riverside view of Section 2-4 at end of test

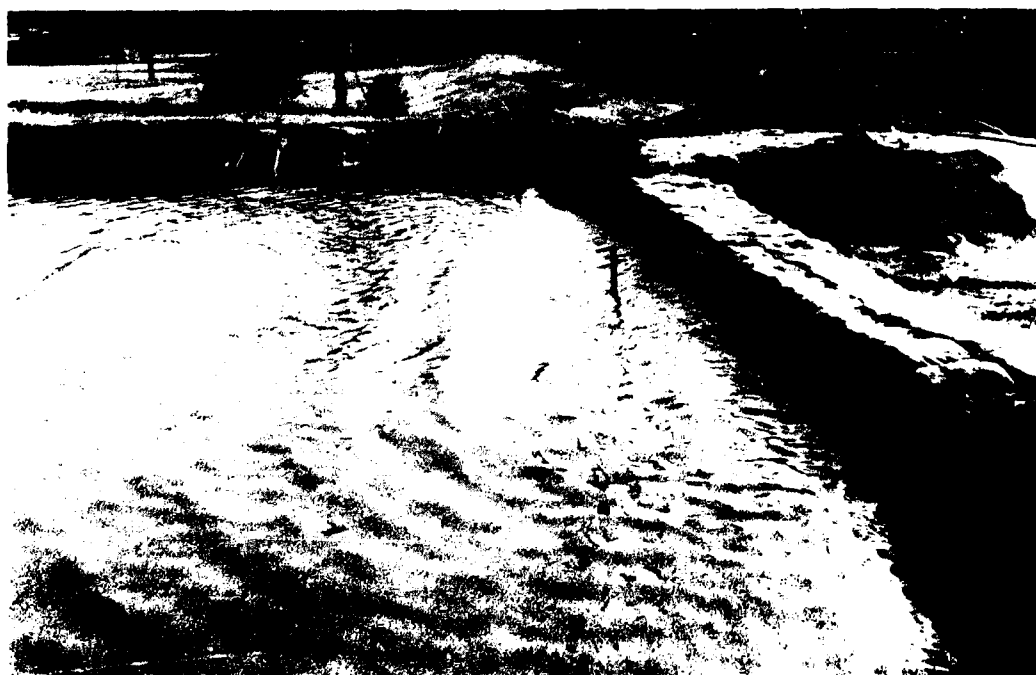
30. Following the static head tests, the structure was exposed to 19 hr of wave action over a period of 191 hr at the 1.0-ft water level (Photo 60). Emptying of the clayey silt-filled bags in the wave action zone started immediately and progressed at a rather rapid rate for the first 3 to 4 hr of wave action. The clay gravel-filled sacks showed some emptying, but it was at a slower rate and to a lesser degree. During the 19th hour of wave action, all noticeable leaching of fill material had stopped, and the small basin was drained. Photos 61 and 62 and cross-sectional soundings (Plate 16) show the condition of Section 2-5 after 19 hr of wave attack. The clayey silt-filled sacks had eroded back and formed a vertical face at the riverside of the structure crown. The clay gravel-filled sacks showed some emptying, but it was to a much smaller degree than that of the clayey silt-filled bags.

Photo 60. Wave action on Section 2-5 (water level = 1.0 ft)

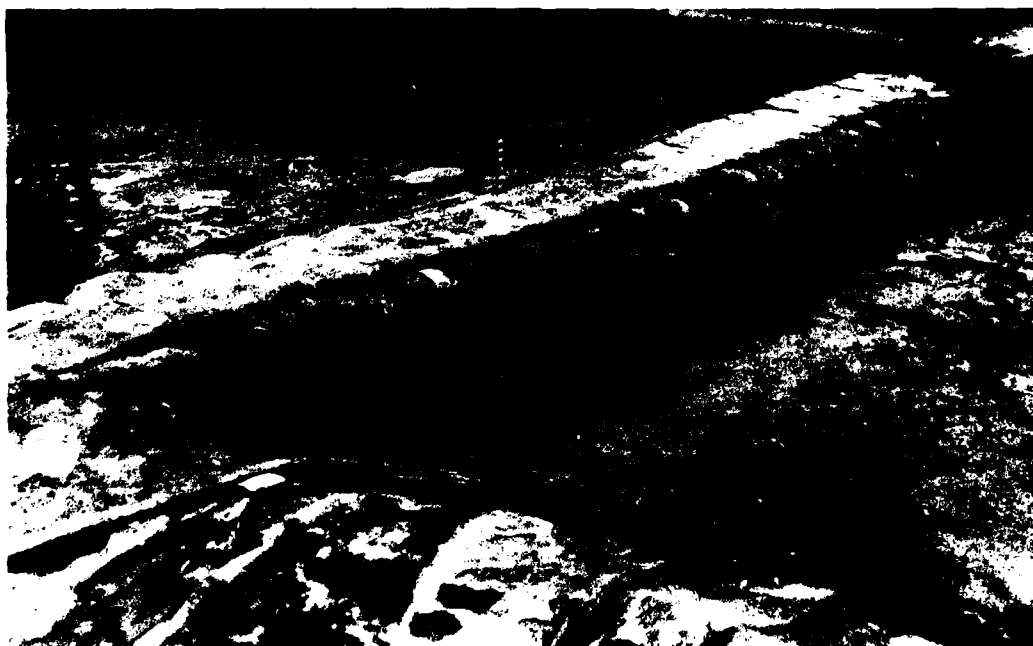
in the small basin. The clayey silt-filled sacks showed rapid erosion during the first 6 hr of wave action, but then the erosion rate slowed and progressed at a slower rate throughout the remainder of the test. The clay gravel-filled sacks showed some additional damage during the first few hours of wave action at the 1.3-ft water level, but no noticeable erosion occurred during the final 3 to 4 hr of wave action. It is felt that once the fines were leached out of the riverside of the clay gravel-filled bags, the coarser fill material acted like a wave absorber and filter which prevented additional leaching of the fines. Although the seepage rate through the structure increased with increasing damage to the structure, the amount neither became significant nor appeared to cause any stability problems. The seepage rates appeared to be equal on both halves of the test section. The test was stopped after 19 hr of wave action at the 1.3-ft water level. Photos 63 and 64 and cross-sectional soundings (Plate 16) show the condition of Section 2-5 at the end of the test.

Photo 64. Landside view of Section 2-5 after 19 hr of wave action at the 1.3-ft water level (end of test)

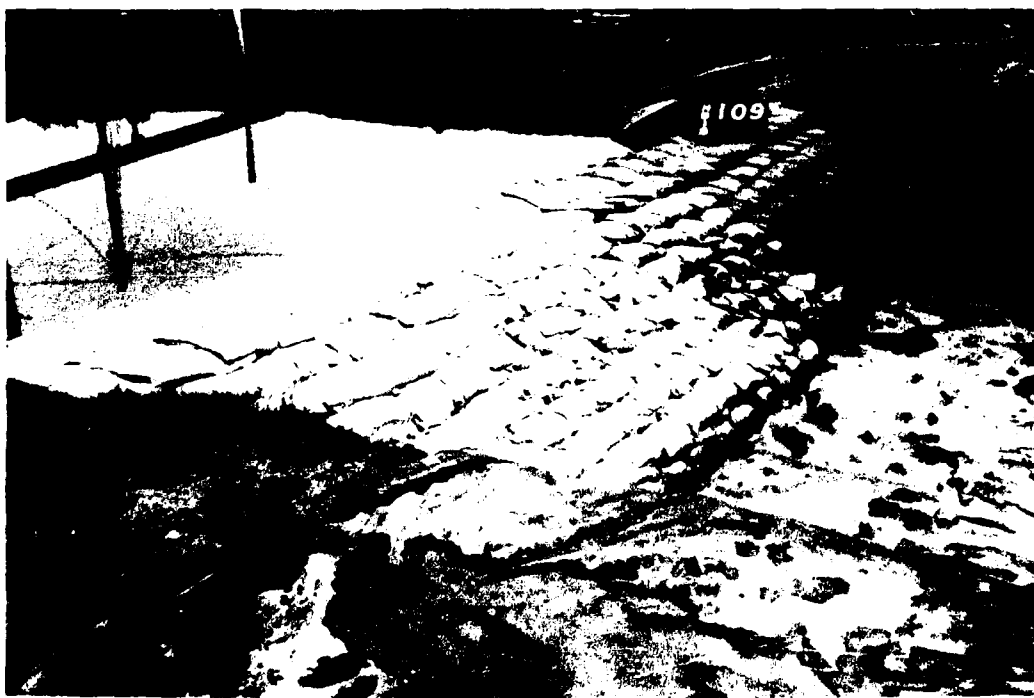
34. Section 4-1 was exposed to 750 hr of between 1.1- and 2.0-ft static differential head. This long duration was the result of being flooded out of the test site for approximately 1 month after the start of the 2.0-ft static head test. Except for the continued deterioration of the burlap sacks, the structure looked very good at the end of this portion of the test (Photos 67 and 68). There was no evidence of leaching of sack-fill material and, even though seepage through the structure was more pronounced on the polypropylene sacks than on the burlap sacks, the amount of seepage was very minor. The static differential head was raised and maintained between 3.0 and 3.35 ft for 48 hr. Seepage through the section increased slightly, but no material leaching was evident. Photos 69 and 70 show the saturation level and seepage through the structure at the end of the static head tests. In summary, Section 4-1 was in good condition at the end of the static head tests (Photos 71 and 72) and was providing its intended protective function. The burlap sacks showed some moderate deterioration, and the spun woven polypropylene showed some minor weathering. The test section appeared to have settled approximately 0.1 to 0.2 ft in the area where the burlap and spun woven polypropylene sacks interfaced, but this had not affected the function of the test section.

Photo 68. Landside view of Section 4-1 after testing 1.1- to 2.0-ft static differential head

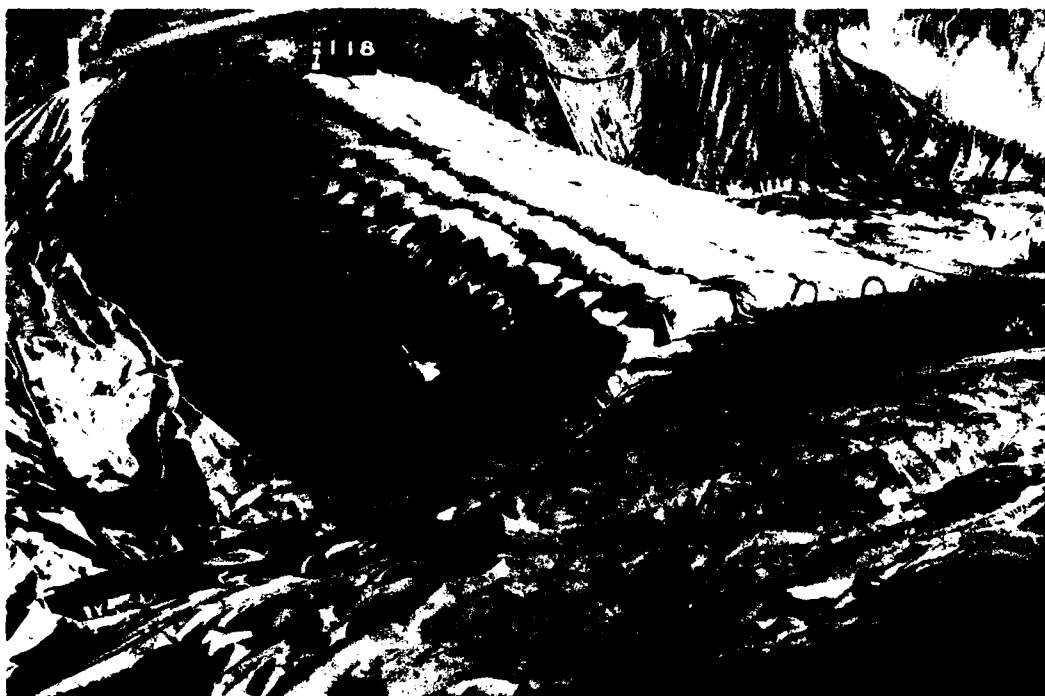
Photo 71. Riverside view of Section 4-1 at the end of the static differential head tests

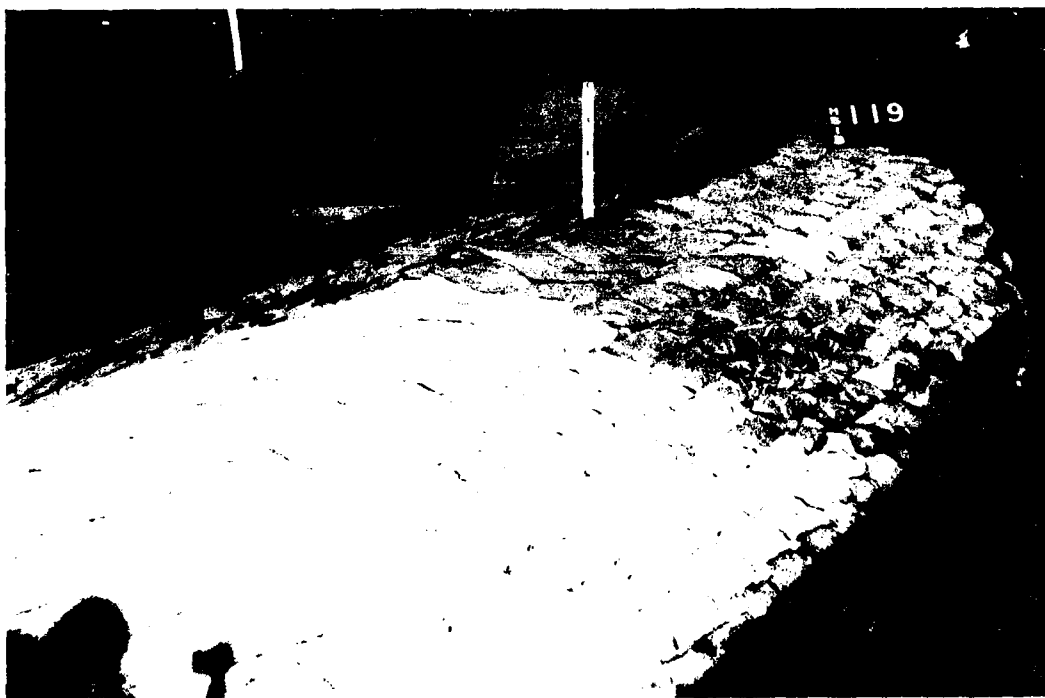
Photo 72. Landside view of Section 4-1 at the end of the static differential head tests

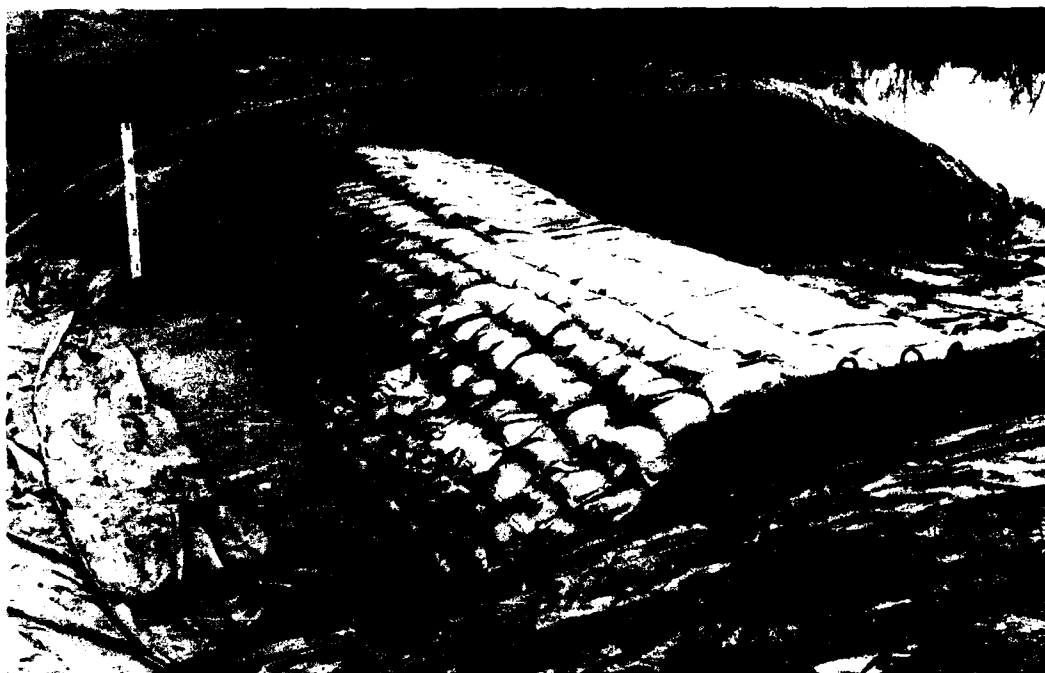
Photo 73. Riverside view of Section 4-1 after 19 hr of wave action at the 1.0-ft water level

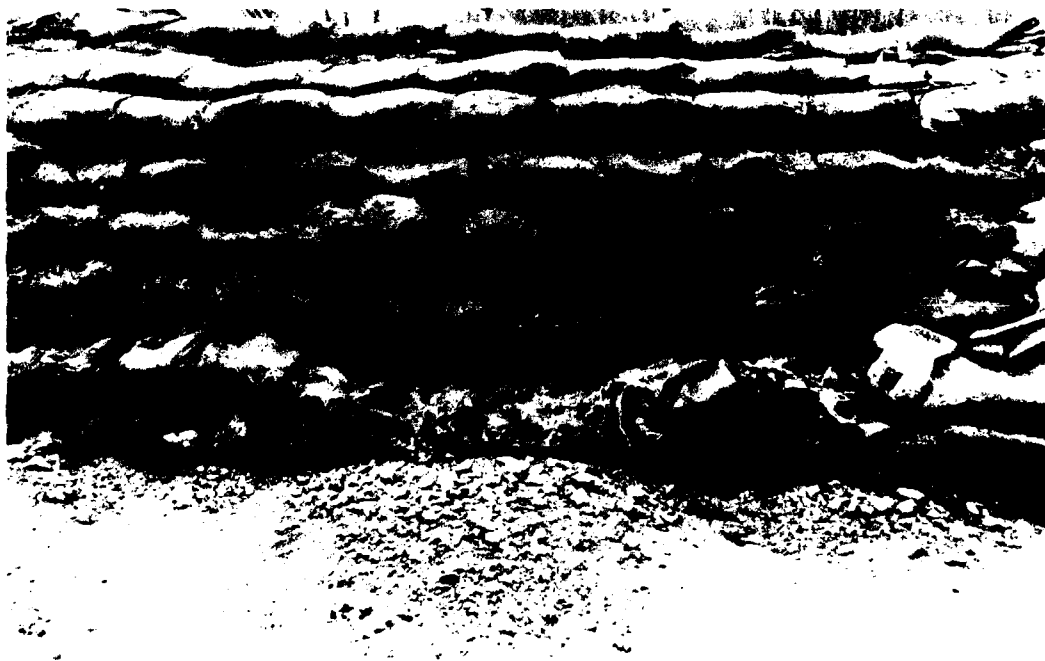
Photo 74. Riverside view of burlap sacks on Section 4-1 after 19 hr of wave action at the 1.0-ft water level

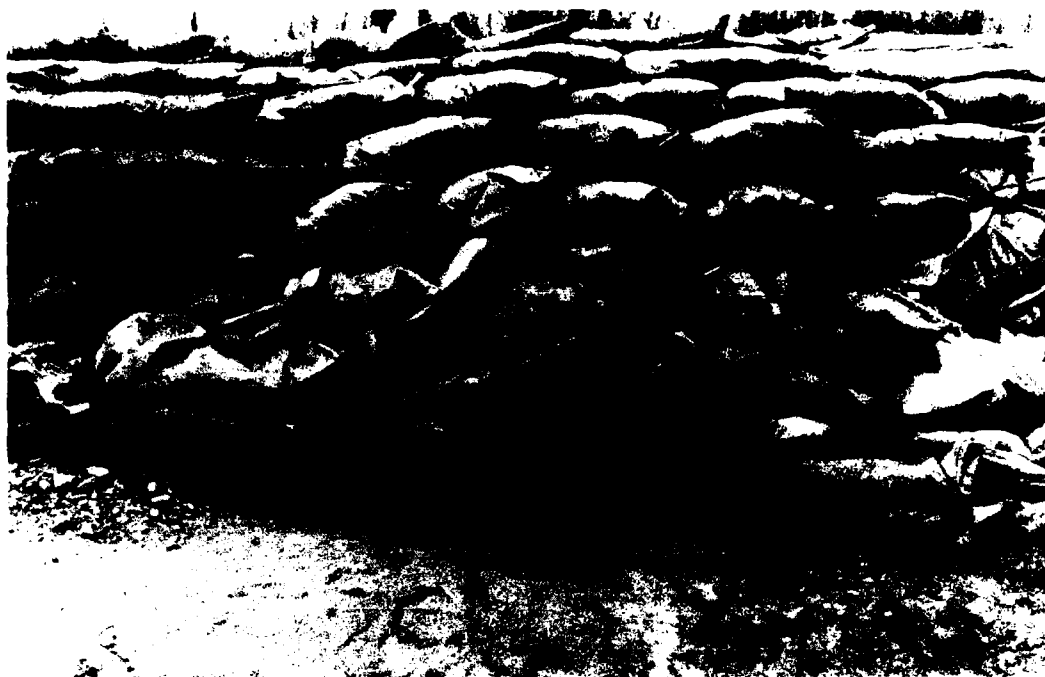
Photo 75. Riverside view of spun woven polypropylene sacks on Section 4-1 after 19 hr of wave action at the 1.0-ft water level

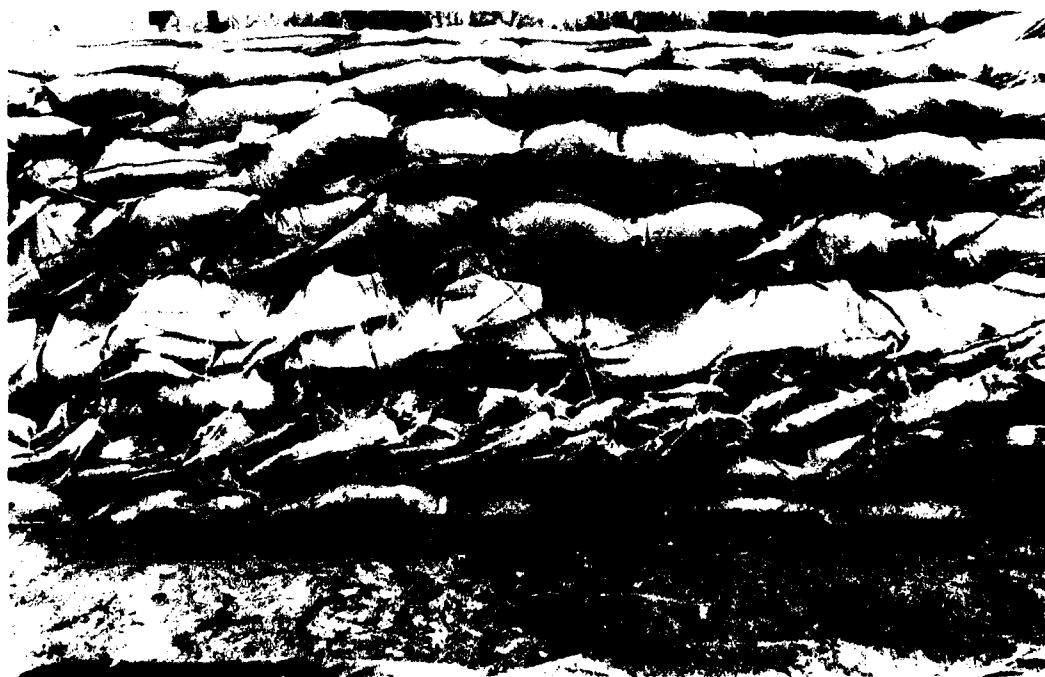
Photo 76. Riverside view of woven polypropylene sacks on Section 4-1 after 19 hr of wave action at the 1.0-ft water level
